Above the Flood: Elevating Your Floodprone House

FEMA 347/ May 2000

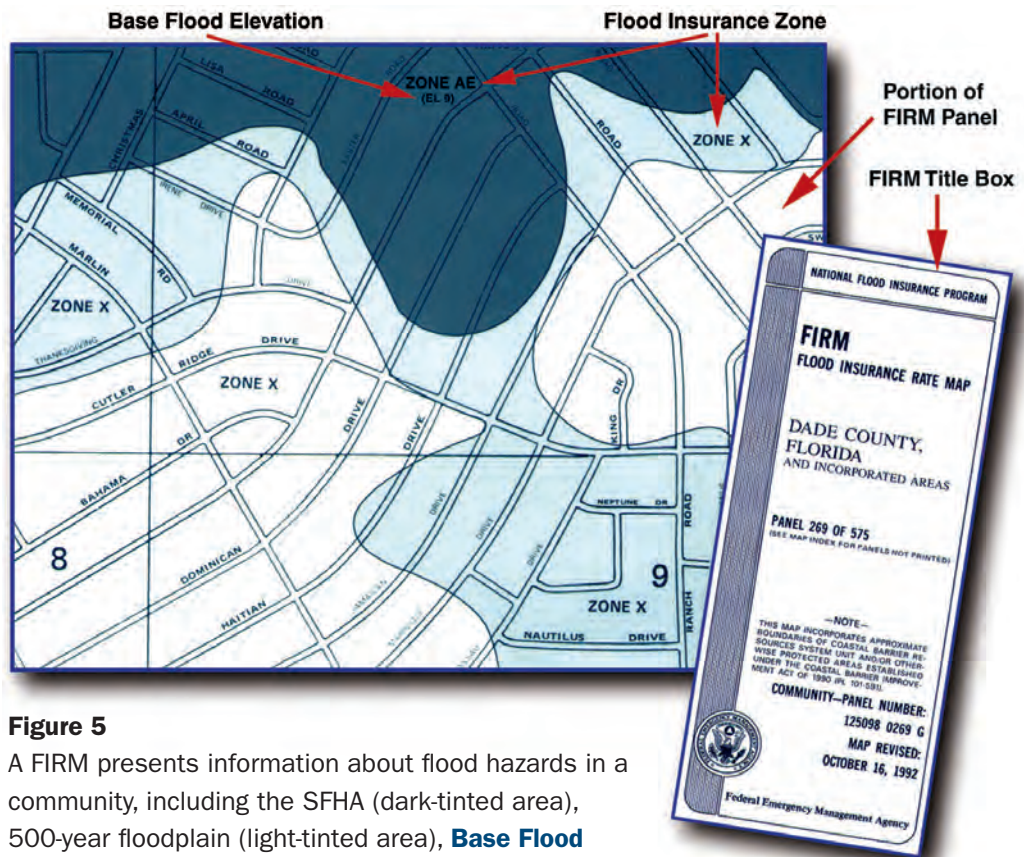
Figure 5 A FIRM presents information about flood hazards in a community, including the SFHA (dark-tinted area), 500-year floodplain (light-tinted area), **Base Flood Elevations**, (BFEs) (number in parentheses), and flood insurance zones (AE and X in this example).

Communities participate in the NFIP by enacting and enforcing floodplain management regulations to reduce future flood risks. At a minimum, these regulations govern construction in the **Special Flood Hazard Areas (SFHAs)** shown on Flood Insurance Rate Maps (FIRMs) issued by FEMA (Figure 5).

Note that the SFHA in the example in Figure 5 is designated Zone AE. This zone is only one of several applied to SFHAs under the NFIP, including V, VE, V1-V30, A, AE, A1-A30, AO, and AH. These zones indicate differences in the types and severity of flood hazards in SFHAs. For the purposes of this publication, it is sufficient to focus on the basic differences between the two main types of SFHA zones—V zones and A zones. The distinction is important because regulatory requirements associated with V zones and A zones differ significantly. As explained later in this chapter, these requirements affect the types of building elevation techniques that may be used under the NFIP.

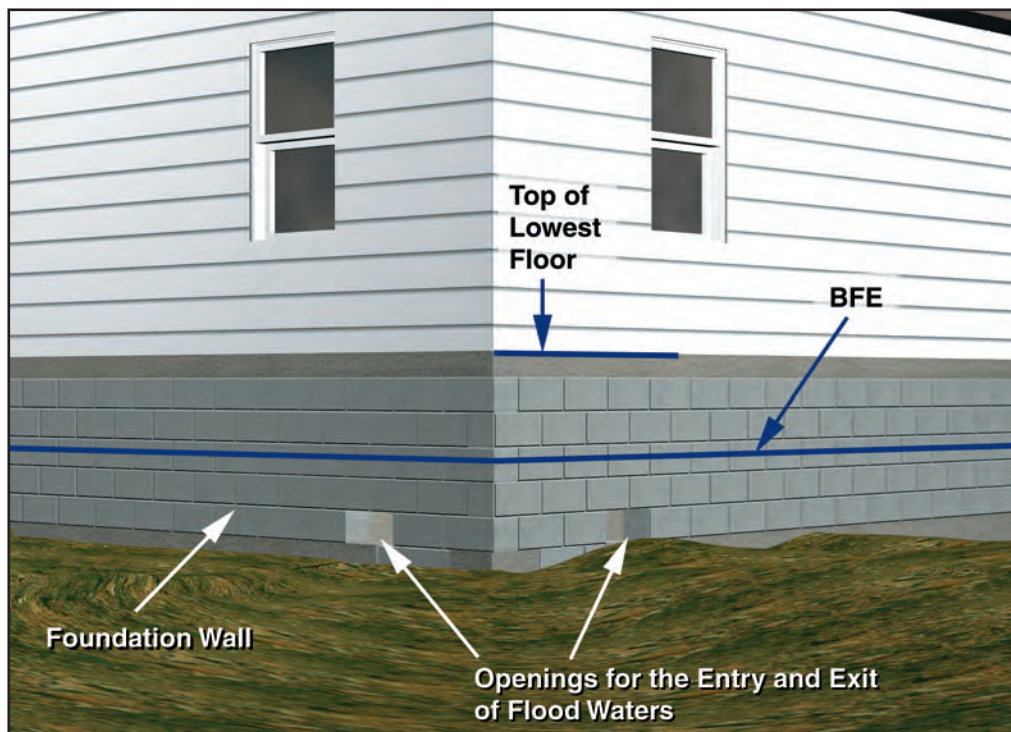
**Figure 6**

In a new, substantially improved, or substantially damaged building in an A zone, the elevation of the lowest floor must be at or above the BFE.

In A zones, where flood hazards are less severe, buildings may be elevated either on an open foundation or on continuous foundation walls below the BFE (Figure 6). Regardless of the type of foundation used, A-zone buildings must be elevated so that the **lowest floor** is at or above the BFE, as shown in Figure 6. If continuous walls are used below the BFE, they must be equipped with openings that allow flood waters to flow into and out of the area enclosed by the walls (Figure 6). Allowing the entry and exit of flood waters ensures that water pressures will be the same on both sides of the walls and reduces the likelihood that water pressure will cause the walls to fail.

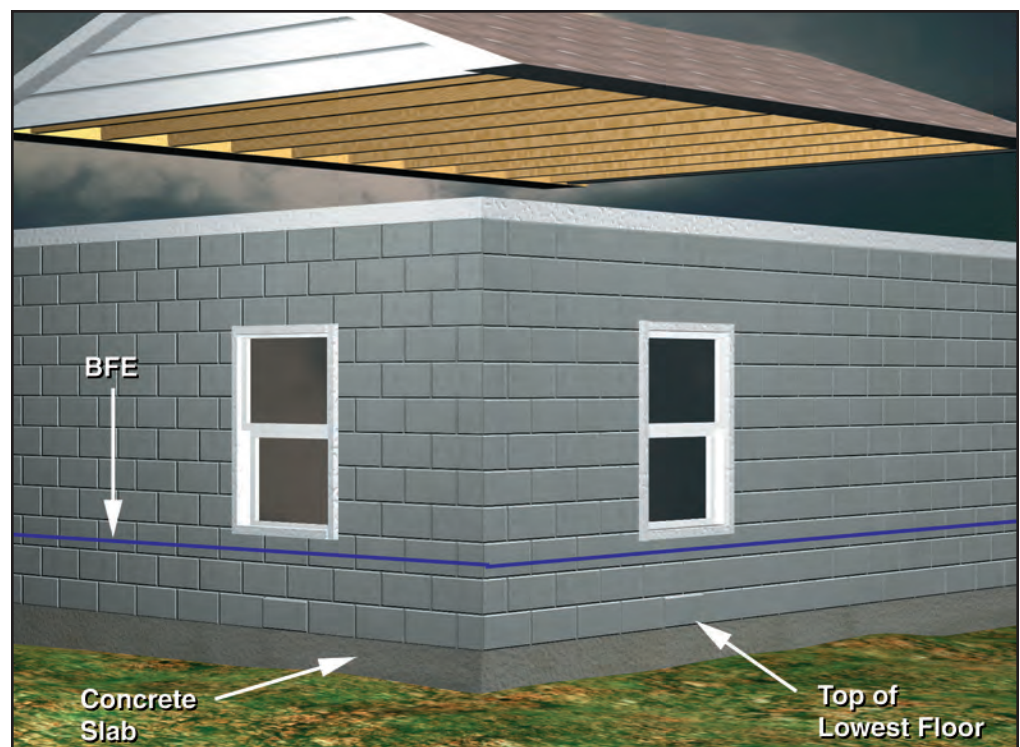
Figure 10
The first step in Technique 1 is removing the roof.

Technique 1 is appropriate for houses with concrete or masonry walls, but not for houses with other types of walls, such as those framed with wood studs, which would be more vulnerable to flood damage. This technique is usually appropriate when the depth of the base flood at the house is no more than 4 or 5 feet above grade. The elevation process begins with the temporary removal of the roof and roof framing, in a single piece if possible (Figure 10). This is commonly done with a crane. The roof is then stored on site so that it can be reinstalled later. The next step is to remove the windows and doors.

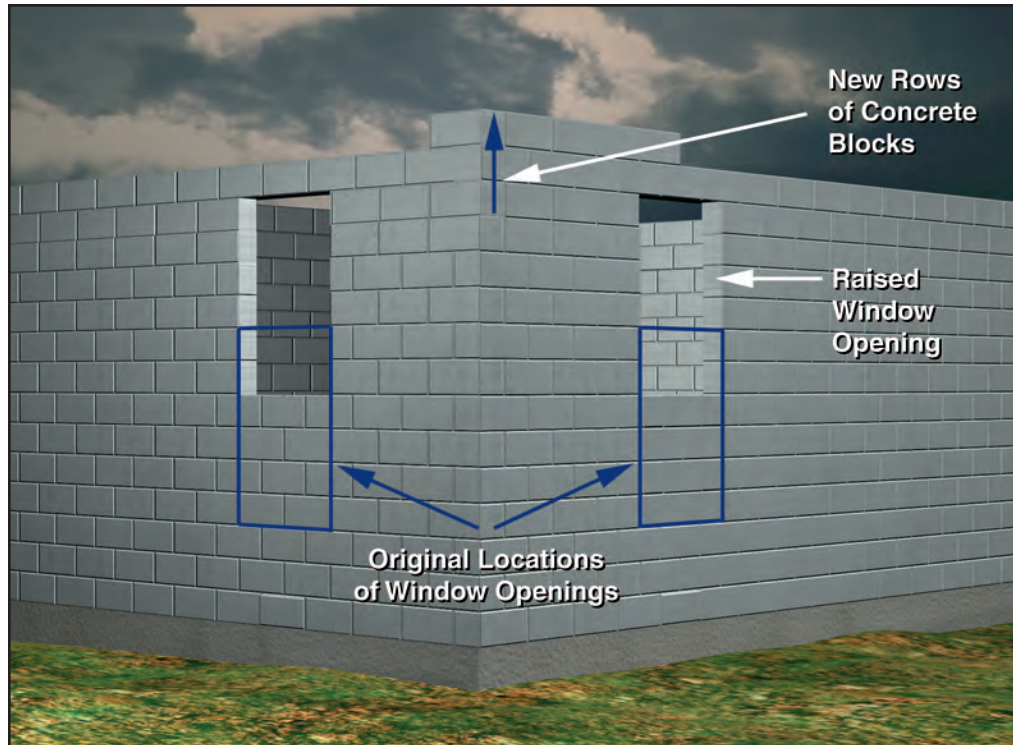
The tops of the walls and bottoms of the window openings are raised with concrete blocks.

After the roof, windows, and doors are removed, several courses of concrete block are added to the tops of the existing walls and to the bottoms of the window openings (Figure 11). A corresponding number of blocks are removed from the tops of the window openings so that the size of the windows will remain the same. In addition, although not shown in Figure 11, concrete bond beams are formed in place at the tops of the extended walls to provide structural reinforcement.

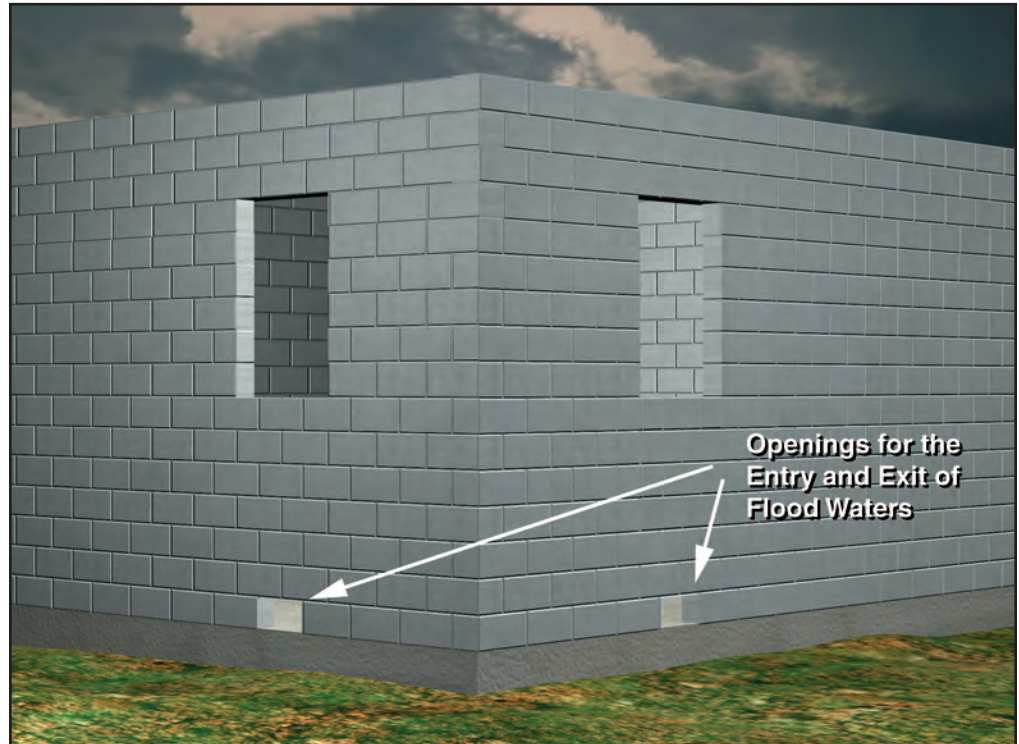
Figure 12
Openings are created in the walls near the ground.

Blocks are removed from the walls of the house at selected locations within 1 foot of the ground (Figure 12). The resulting openings will allow flood waters to flow into and out of the lower area of the house so that the water pressures on both sides of the walls will remain the same. The roof and windows are then replaced, and a new wood-frame floor is constructed above the flood level (Figure 13).

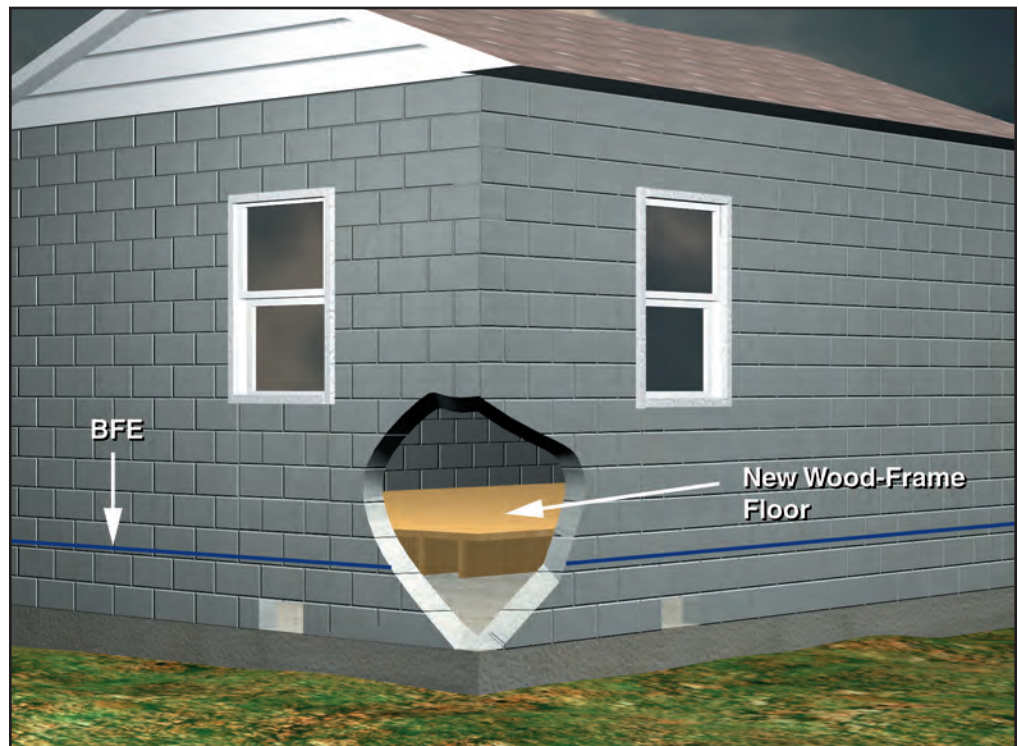
Figure 13
A new wood-frame lowest floor is constructed above the flood level, and the roof, windows, and doors are reinstalled.

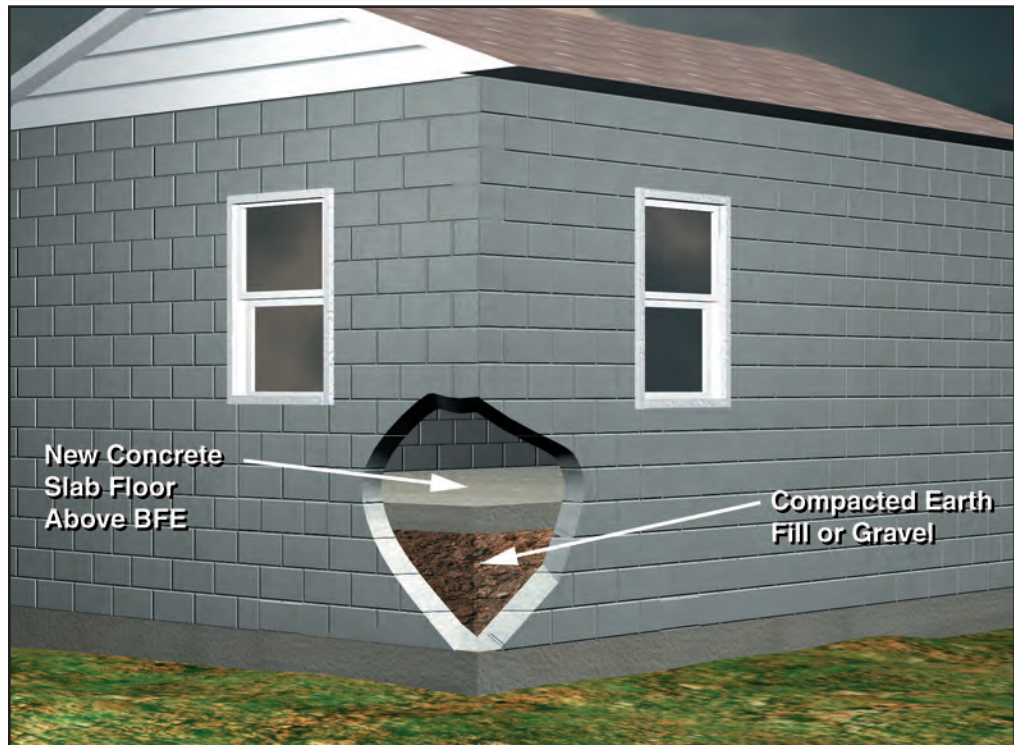
Figure 14
An alternative to building an elevated wood-frame floor is installing a new, elevated concrete slab floor on fill placed over the old slab.

A homeowner who chooses Technique 1 may decide to build a new concrete slab floor instead of a wood floor (Figure 14). When this option is chosen, compacted fill dirt or gravel is placed on top of the old slab and the new slab floor is poured on top. Because the area below the new floor is filled with dirt or gravel, wall openings are not required.

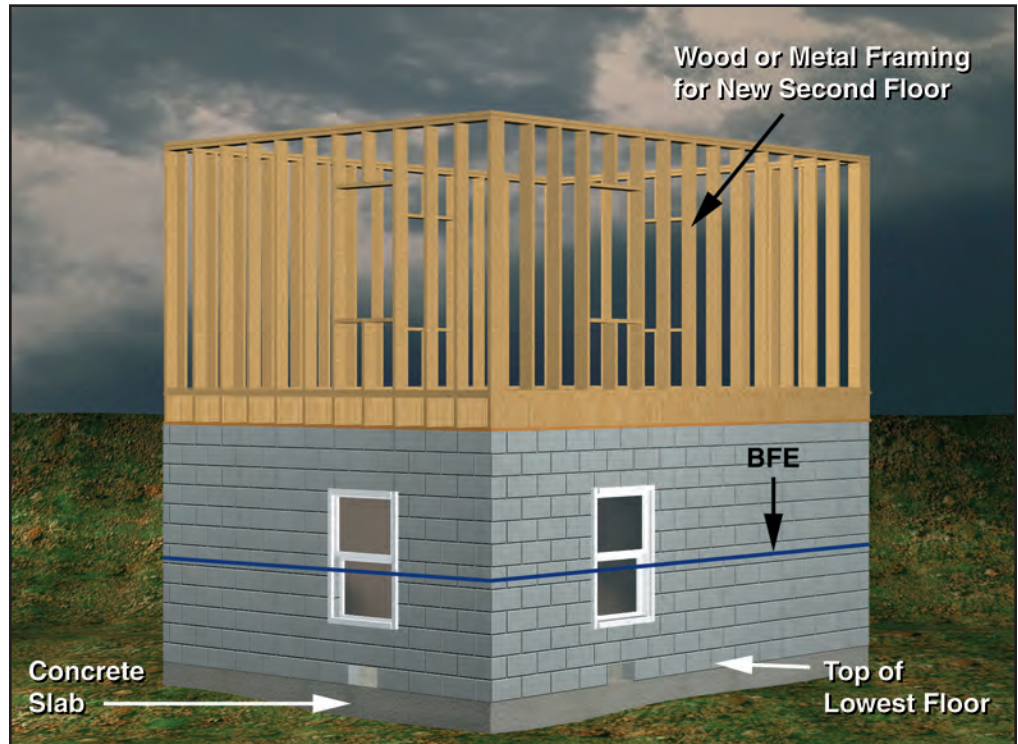
Figure 15
The new second-story floor and walls are built on top of the existing lower story.

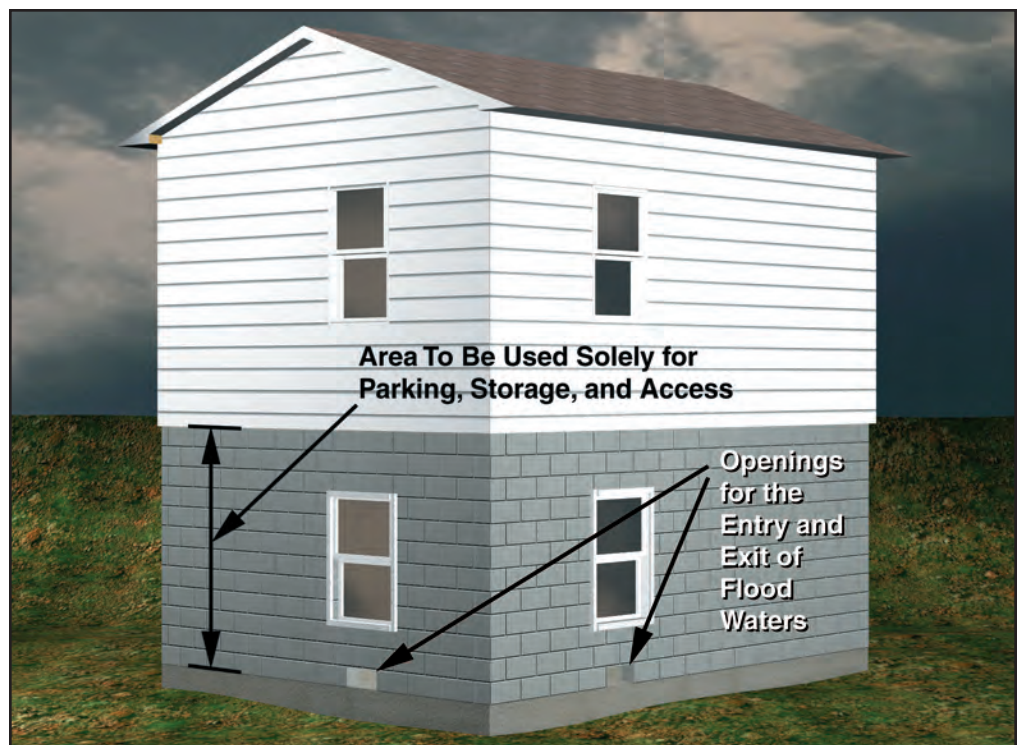
Figure 16
The new second-story walls are covered with siding or stucco.

Some homeowners prefer that the second story be constructed of masonry, but wood- or metal-framing is more common, primarily because it is lighter and less expensive. The roof is replaced, and blocks are removed from the walls to allow flood waters to enter and exit. Exterior sheathing is then added to the framed walls of the second story, the new windows are installed, and siding or stucco is applied to the sheathing (Figure 16).

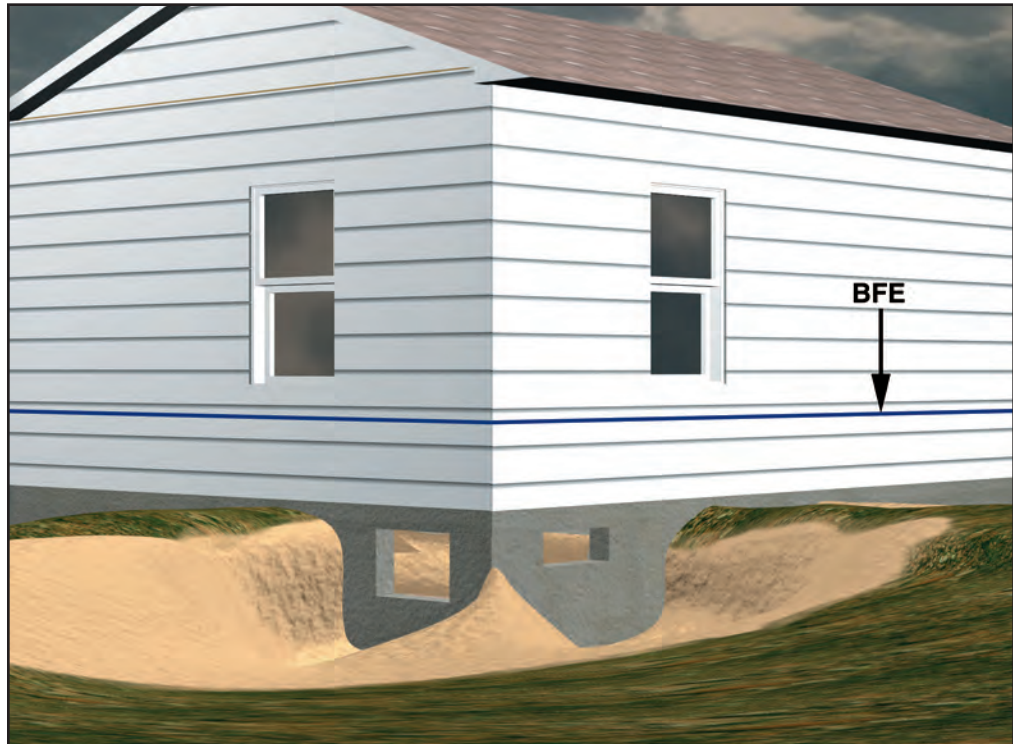
Figure 17
Trenches and tunnels under the slab provide access for the jacks and I-beams that will lift the house.

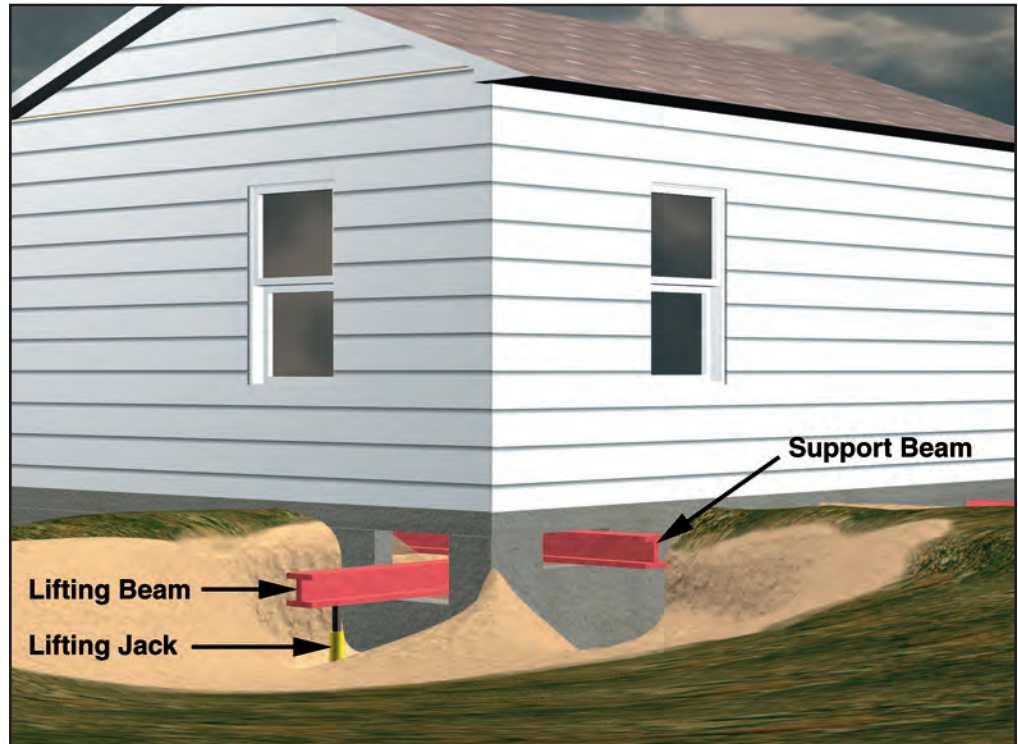
Figure 18
With I-beams and jacks in place, the house is ready to be lifted.

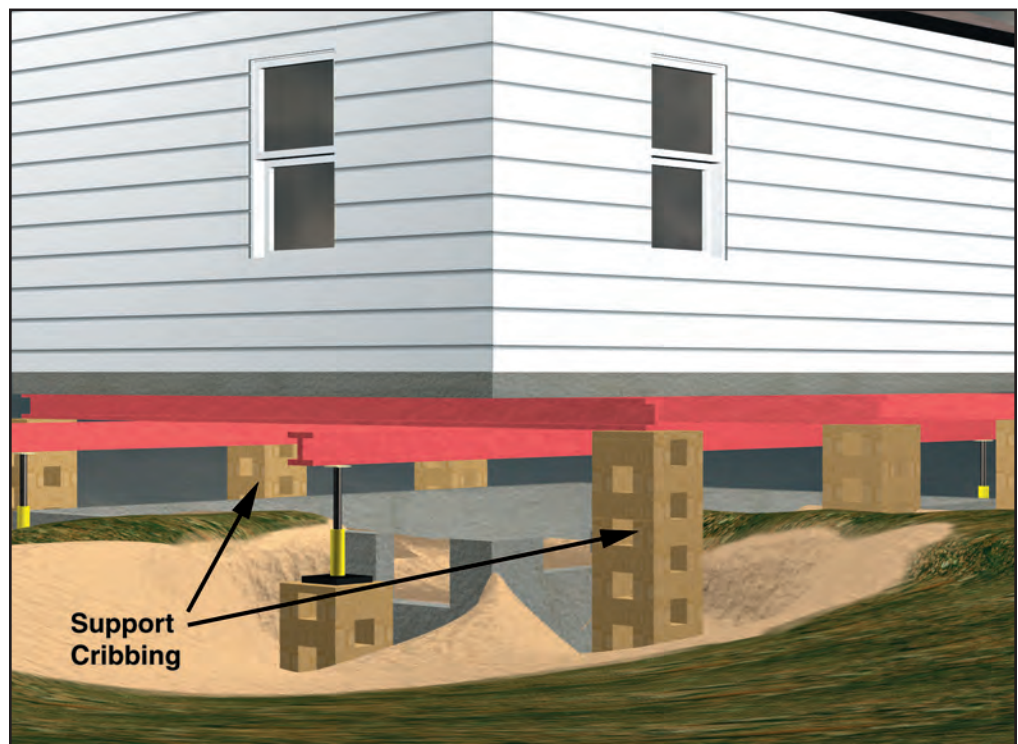
Figure 19
The house is temporarily supported on cribbing.

The house is then jacked up. When the jacks have extended as far as possible, the house must be supported temporarily while the jacks are raised. Both the house and the jacks are usually supported on “cribbing”—temporary piles of crisscrossed timbers (Figure 19). The jacks are then used to raise the house higher.

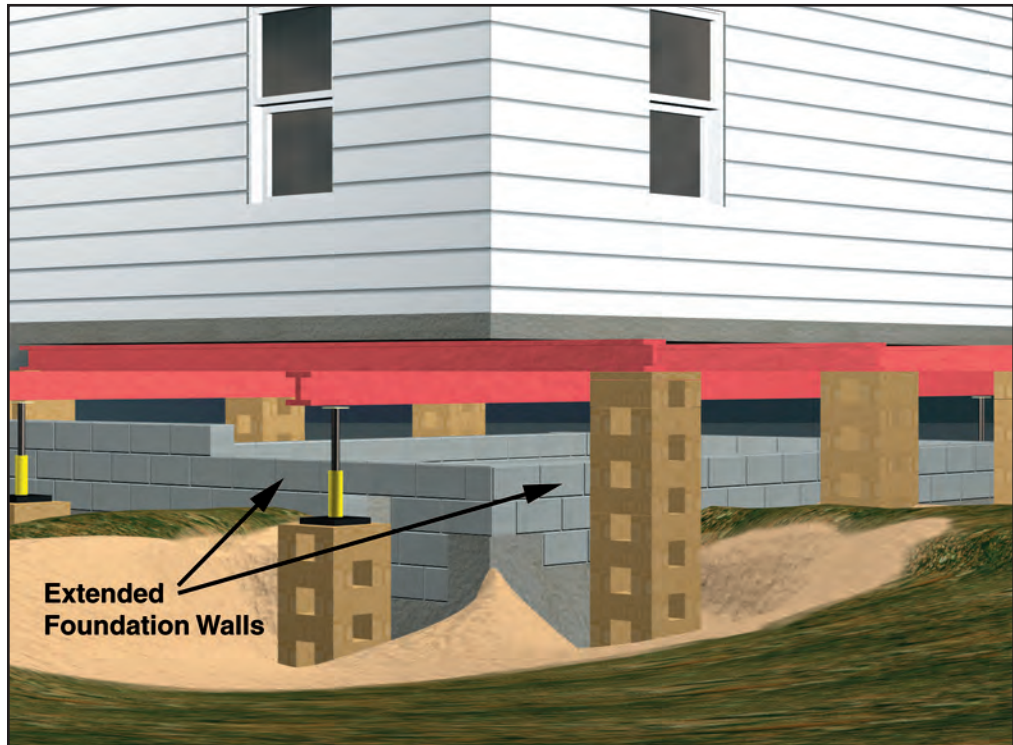
Figure 20
New, extended
foundation walls are
constructed with
concrete blocks.

This process is repeated until the house is raised to the desired height. The foundation walls are then extended upward with additional rows of concrete block (Figure 20). As in the previous techniques, openings are made in the walls within 1 foot of the ground so that flood waters will be able to flow into and out of the area below the elevated floor. The jacks and beams are removed, and the openings left around the beams are filled with blocks (Figure 21).

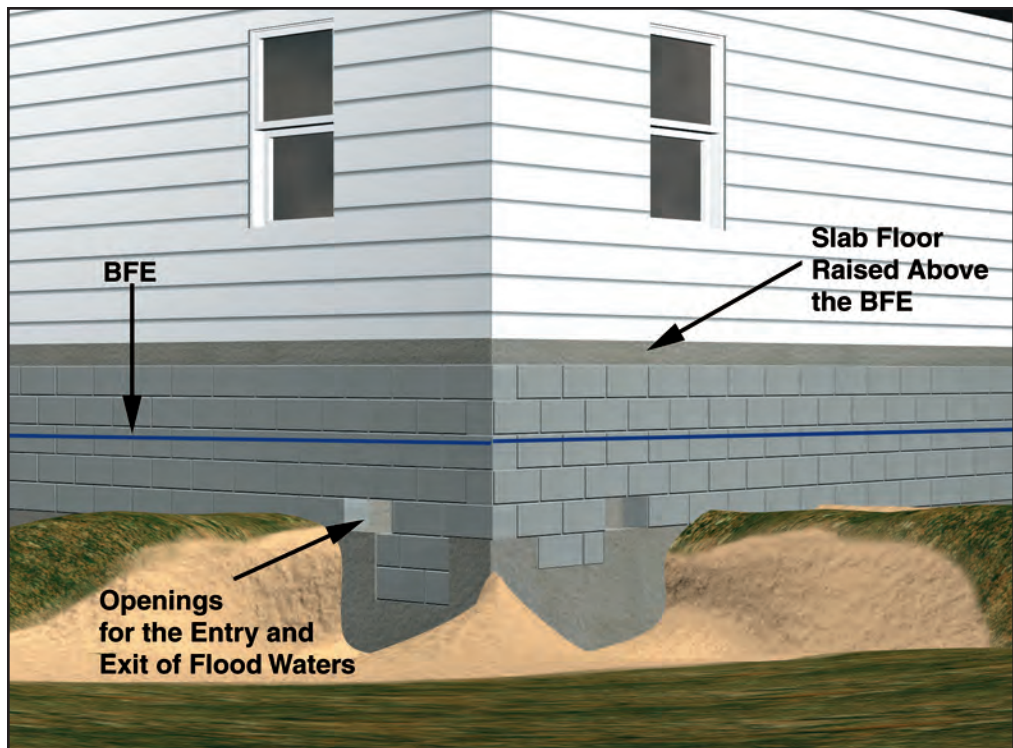
Figure 21
Elevated house and
slab on new, extended
foundation walls.

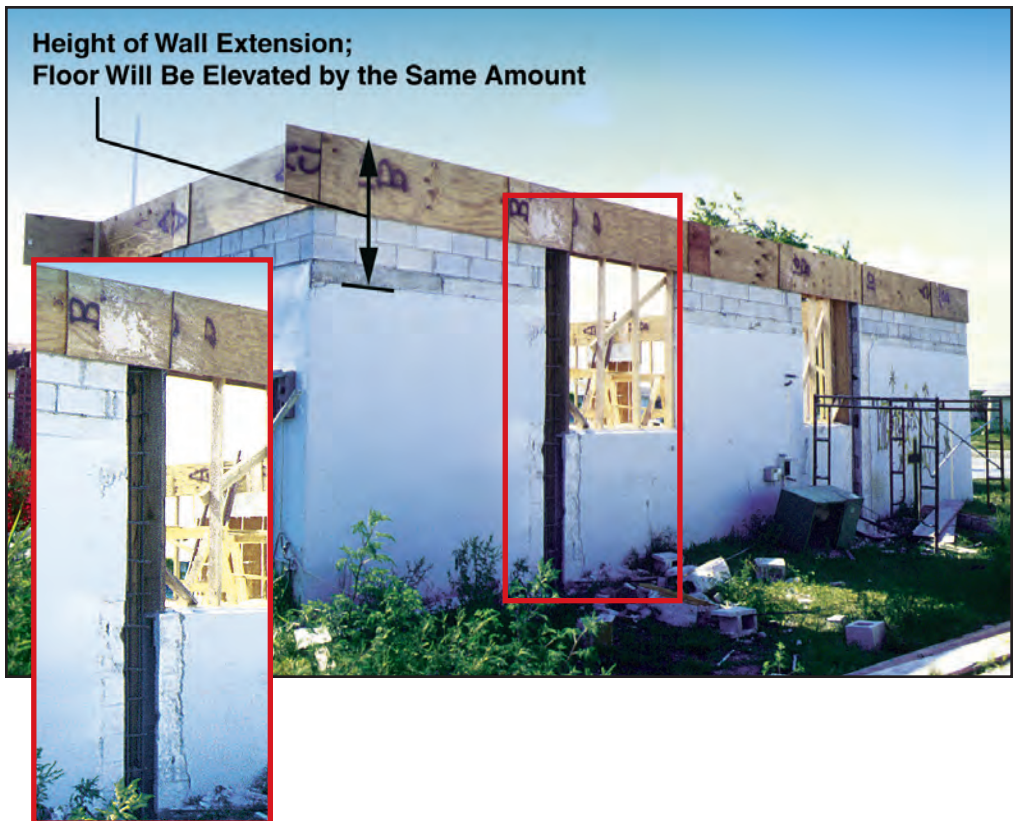
Figure 24
Another view of the extended walls. The vertical cuts in the walls next to the windows are for concrete tiedown columns that will be cast in place to further strengthen the extended walls against wind loads. The owner of this house was able to meet the elevation requirement by raising the floor only a few feet, as indicated by the amount that the walls have been extended.

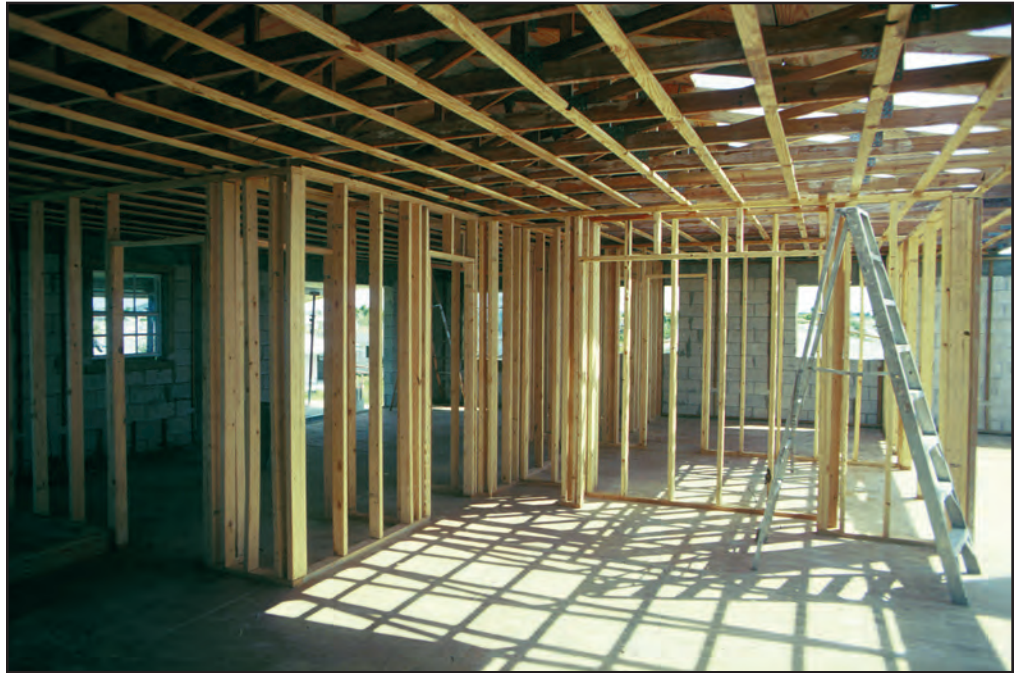
Figure 48
Wood 2 by 4 studs
were used to frame
the interior walls of
the second story.

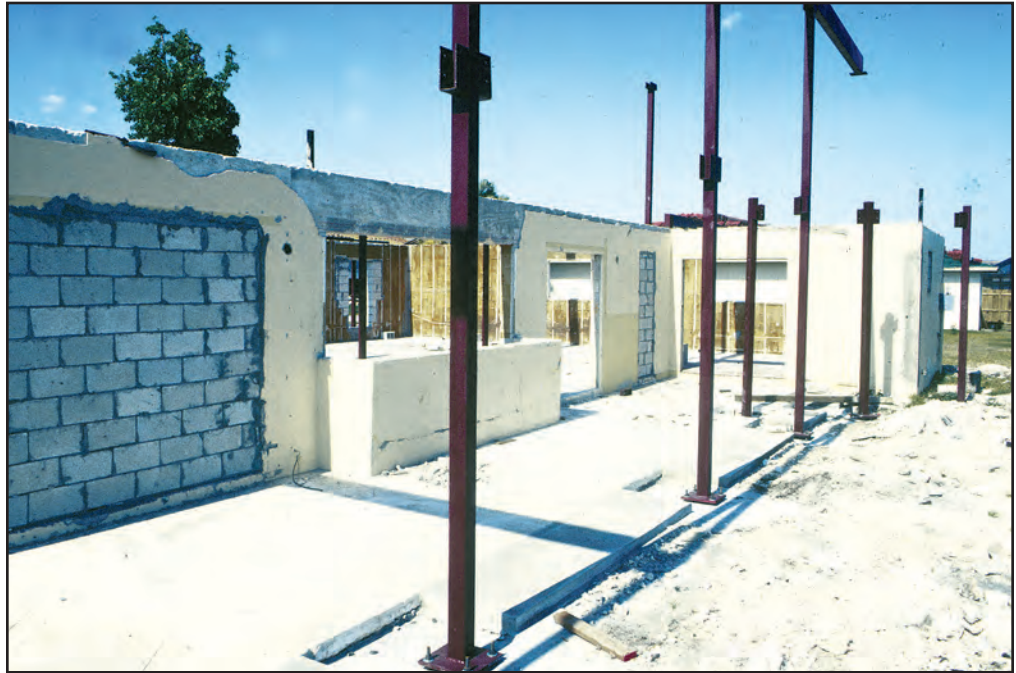
Figure 52

The existing first-story walls have been strengthened by the addition of concrete block. Metal columns and beams have been added to help support the new second story.

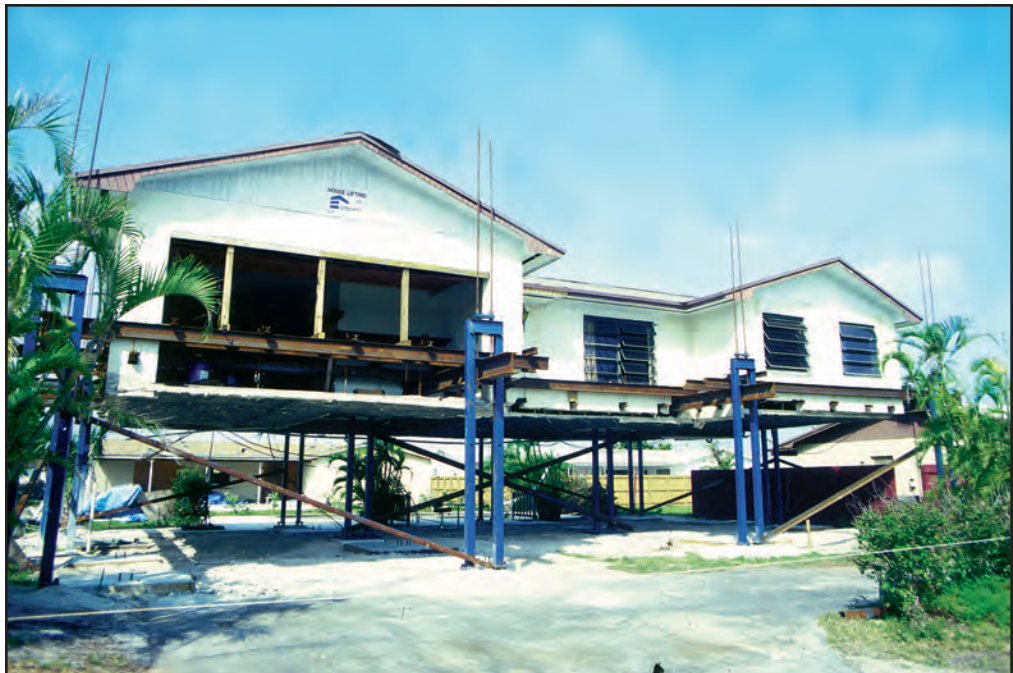
Figure 81
The house and slab were raised one full story.
